# IMPACT OF RUNOFF POLLUTION

## SWIFT CREEK RESERVOIR CHESTERFIELD COUNTY, VIRGINIA

T.A. Pakurar, Ph.D.  
Hands Across the Lake  
November 12, 2002

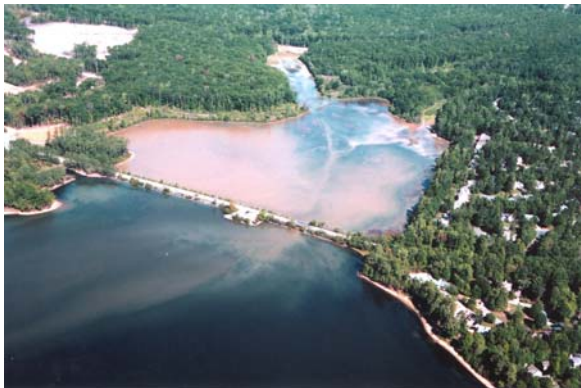
Genito Road Causeway 9/5/02; Photo by Silver Cloud Aviation

- The sediment discolored about 50 acres of the reservoir north of Genito Road Causeway. Plumes entered the main body of the reservoir from the culvert under Genito Road and discolored a visible strip of the reservoir ~3 miles away at Sunday Park. The reservoir north of Genito Road was similarly discolored in May 2002 and again on 10/17/02.

- Plumes of muddy water broke through the Genito Road causeway and entered the main reservoir.
- On 9/5/02, John Ficklin of Silver Cloud Aviation, took aerial photographs of the lake and recorded his visual sightings.

- Photos 1 & 2 are taken from the reservoir looking north across the Genito Rd. Causeway. The mud plumes extend into reservoir more than 1/2 mile.
- The mud is very visible a week after it rained.

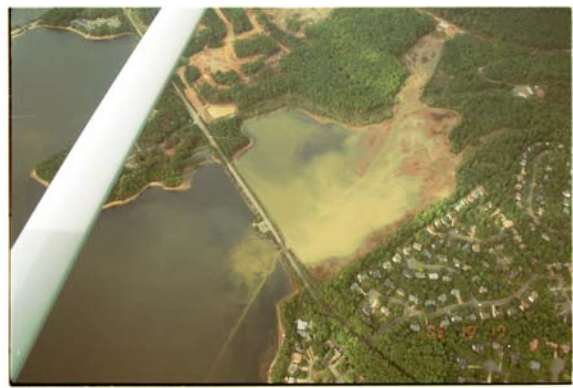
Causeway 10/17/02

Photo by T.A. Pakurar

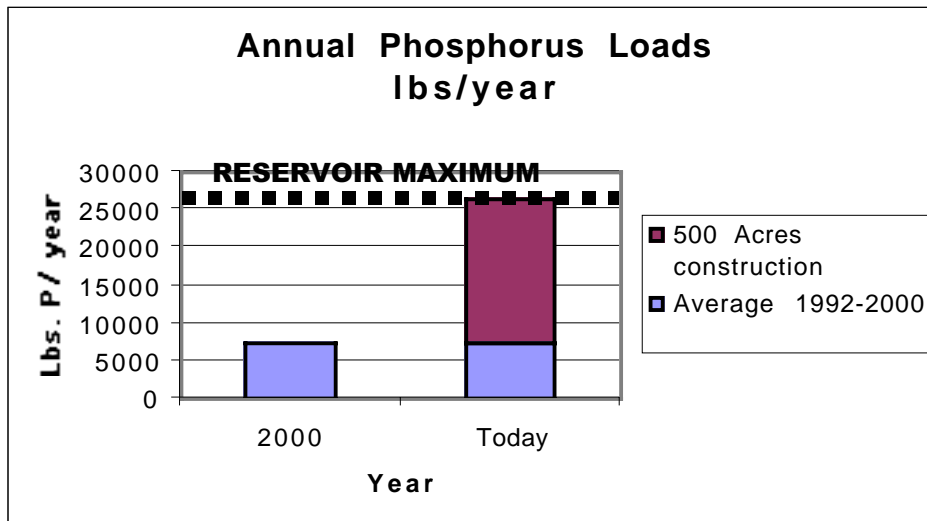
**Chart 1: Annual Phosphorus Loads**

*Annual phosphorus export coefficients were calculated based on 80 Acres of construction and 43.1" of annual rainfall. These ranged from 17-62 lbs./acre/year with a median value of 42 lbs./acre/year.*

HAL’s concern is that if the pollution from this event is indicative of that for the entire watershed, then runoff pollution from just 500 acres under construction (less than 2% of the watershed) is sufficient to destroy the reservoir. The phosphorus in such runoff (20,000 lbs. per year) would take the in-lake concentration over the legal maximum (0.05 mg/l) as mandated by county ordinance.

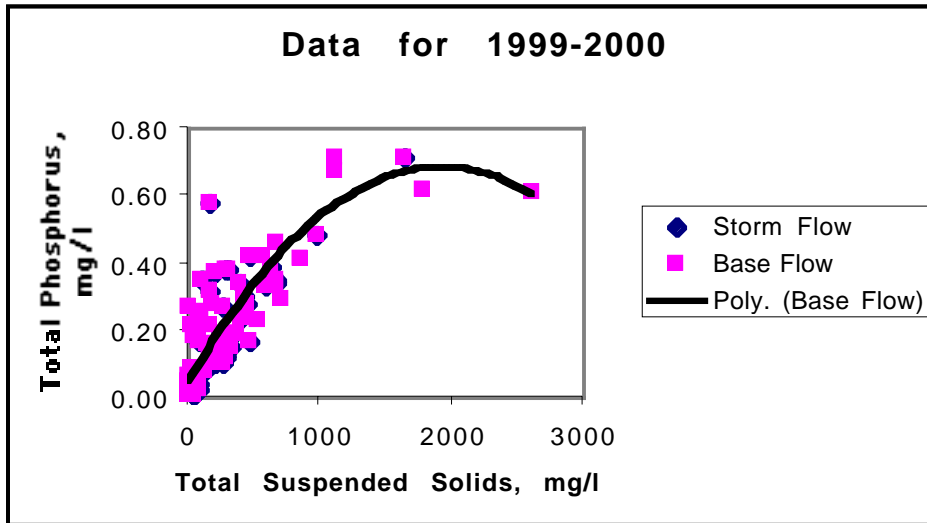
**Figure 1: Phosphorus Quantity vs. Amount of Sediment**

The tributary data for 1999-2000 is plotted in Figure 1 below:

The relationship shows that if one can see or measure the amount of sediment flowing in muddy runoff discharge, then the amount of phosphorus can be predicted.

This limit is reached at ~100 mg/l. Total Suspended Solids. In other words, if one can visibly see the muddy color in storm water runoff, then the concentration of phosphorus is too high. Muddy runoff therefore can be interpreted as an early warning signal that the phosphorus levels may be too high and that the erosion and sediment control measures are not working.

- County monitoring data is used to confirm that most phosphorus is transported by attachment to the sediment particles. A relationship of phosphorus amounts to the amount of total suspended solids is presented. High phosphorus amounts are usually accompanied by high sediment visibility in mildly discolored runoff water.
